Reference catalog

# Together we create the paper of tomorrow.

## Immerse yourself in the world of product applications from Röchling Industrial Oepping.

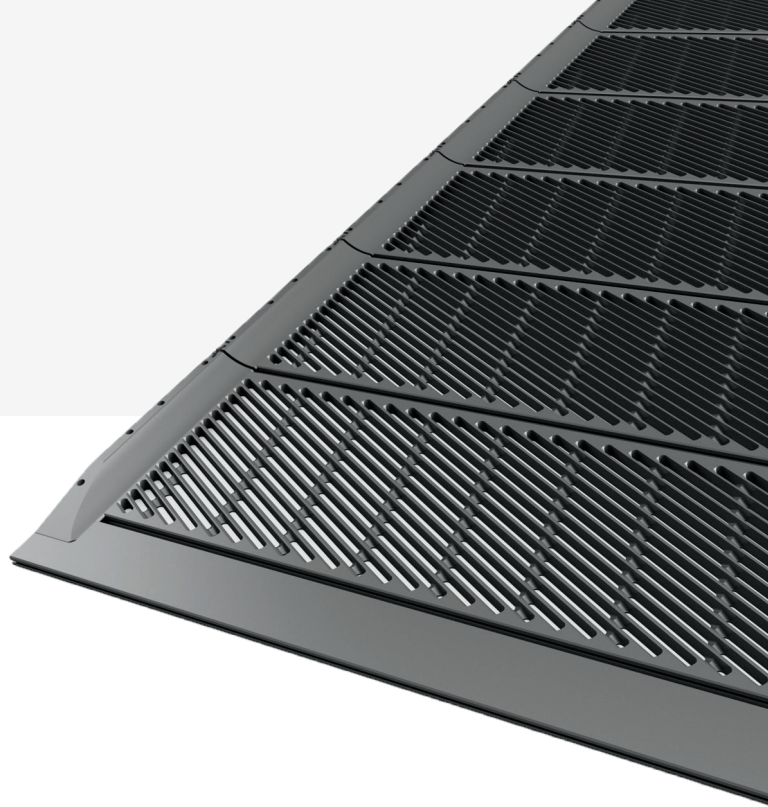
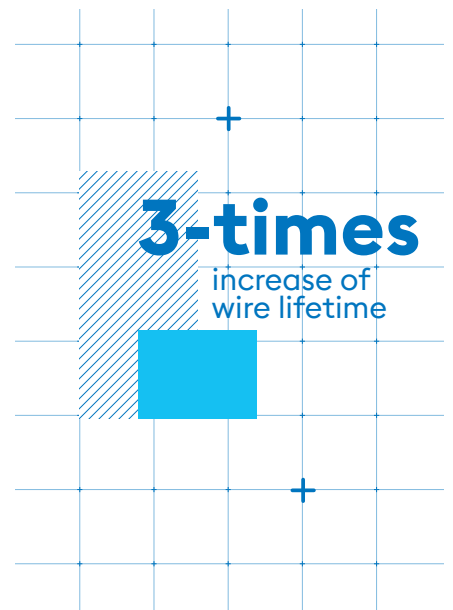
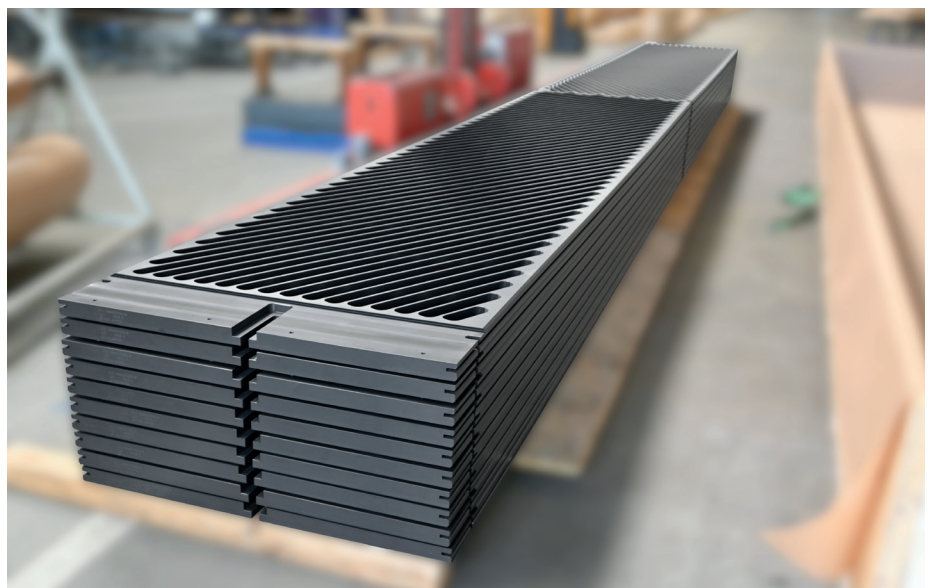
## ROBALIT-61 SUCTION BOX COVER FOR CHEMI-WASHER

Röchling Industrial Oepping installed a new set of covers made of ROBALIT-61 material, which contains special lubricants that ensure better gliding properties. This has a positive effect on the lifetime of the wire and energy consumption. The covers were replaced with a herringbone pattern, which reduces the risk of high wire wear due to sharp edges (better support).

The original ROBADUR covers had been in use for almost 30 years. Although they showed only moderate mechanical wear, they were already very sharp-edged. This was the main reason that led to a significant reduction in wire lifetime.

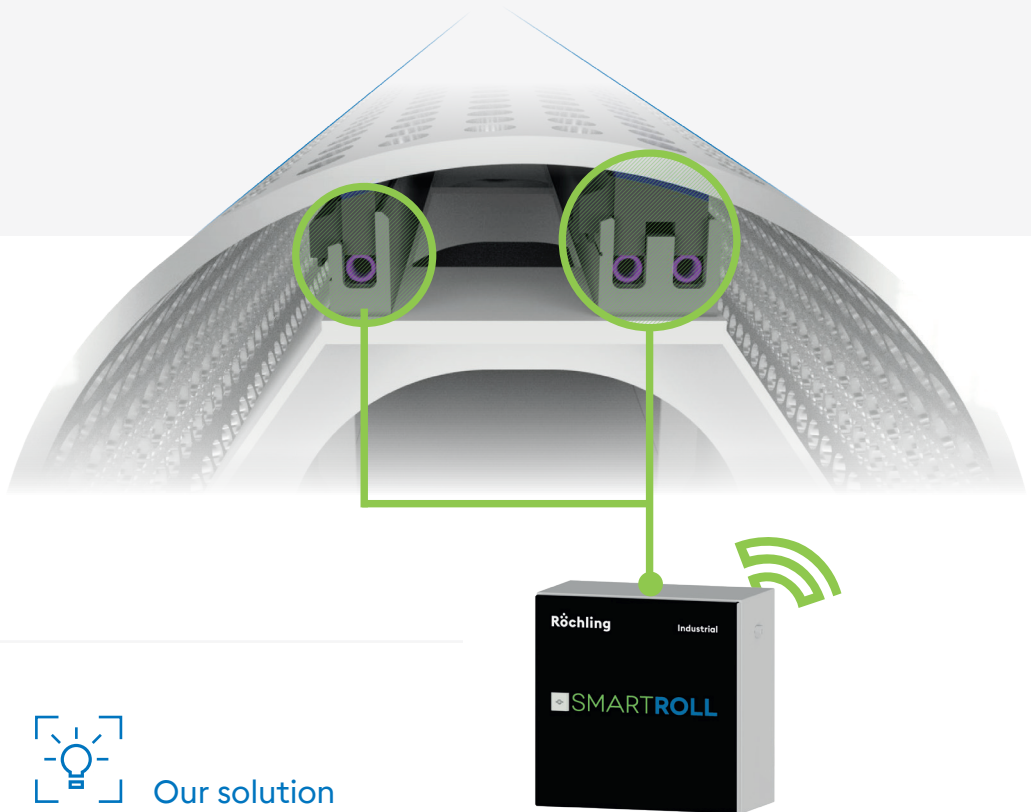
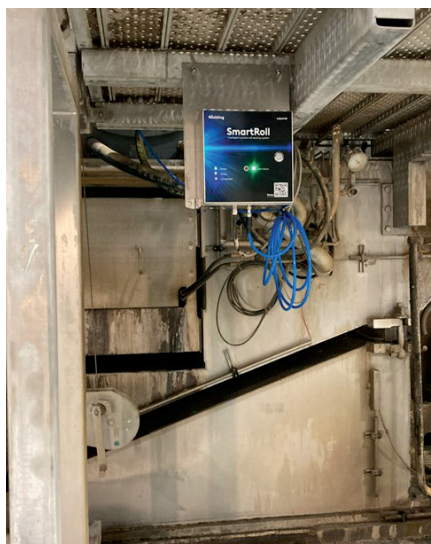
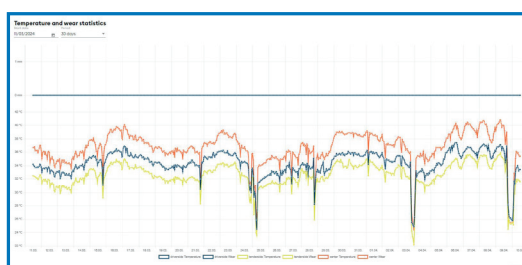
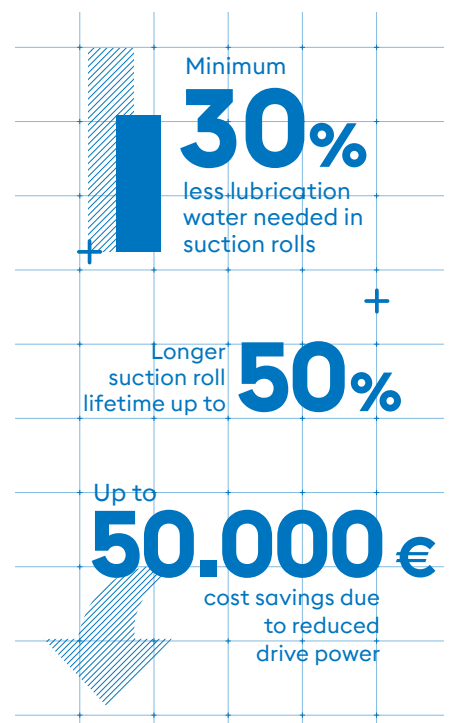
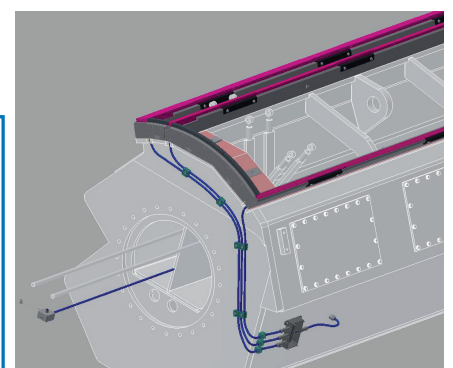
## SMARTSEAL INCL. SMARTROLL-BOX

ROBASEAL-A sealing strips equipped with our smart electronics. This enables the wear condition to be recognized and the surface temperatures to be measured over the entire lifetime of the sealing strip.

The measured values are now transmitted via SMARTBOX to the Röchling PORTUS platform, where the actual condition of the sealing strip can be checked and monitored at any time. In addition, warning thresholds have been set up which immediately inform a specified email distribution list when predefined limit values are reached.

As the surface temperature is now known thanks to the smart electronics, the amount of lubricating water can be significantly reduced (reduction in the amount of water until the surface temperature rises). In addition, any maintenance work can be better planned by knowing the wear condition.

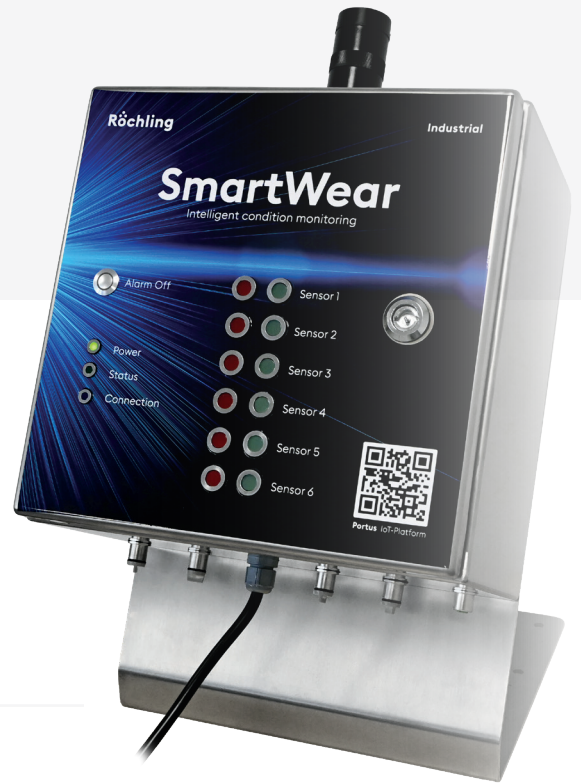
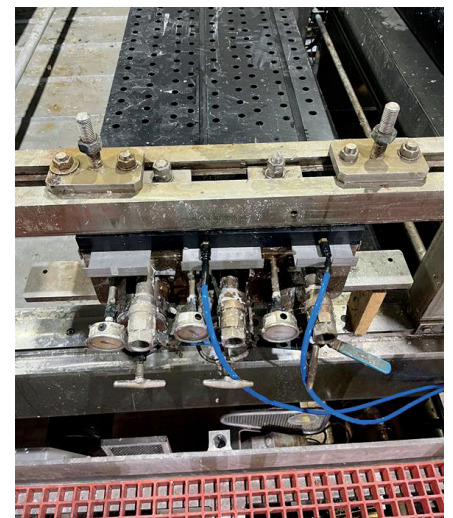
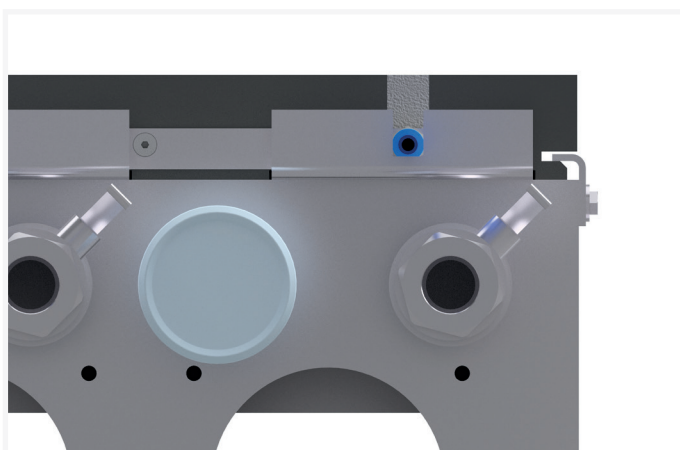
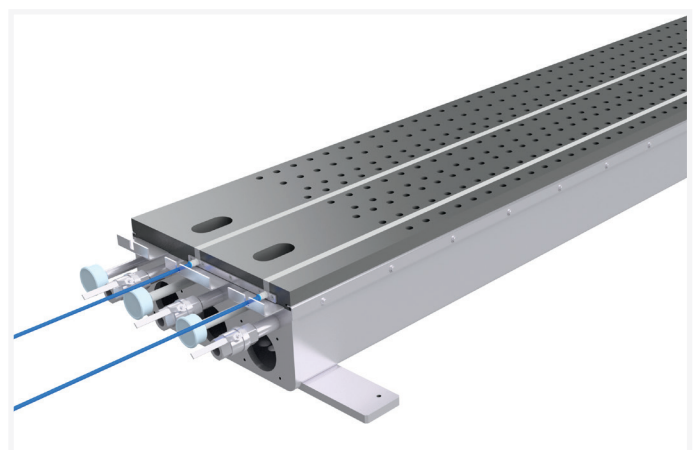
## ROBADUR-OS SMARTCOVER

The cover was equipped with various sensors: On the one hand, several sensors for monitoring the temperature to check whether different temperature values have a negative effect on the service life of the covering. On the other hand, a wear sensor was also integrated, which monitors the wear over the entire wire width and sounds an alarm before a critical level is reached.

The new wear sensor informs before a critical wear level is reached, so there is still enough time to change the cover before damage occurs.

The cover is used on a pulp dryer and is installed directly under a steam blow box. In the past, the customer had struggled with irregular signs of wear. It was not 100% clear what exactly caused this issue, but it was most likely due to different temperatures. In some cases, the wear on the cover reached critical levels, which in the worst case could damage the wire.

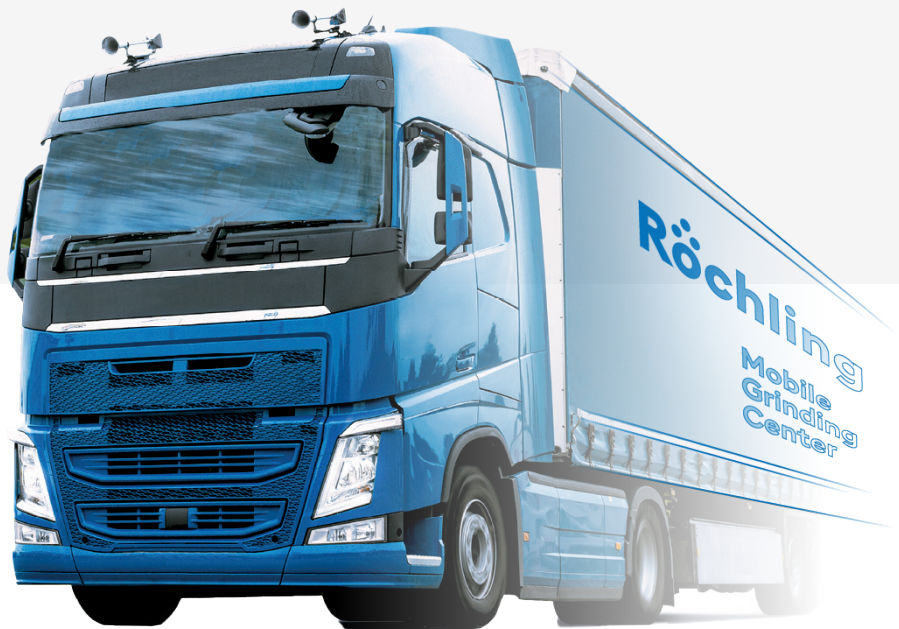
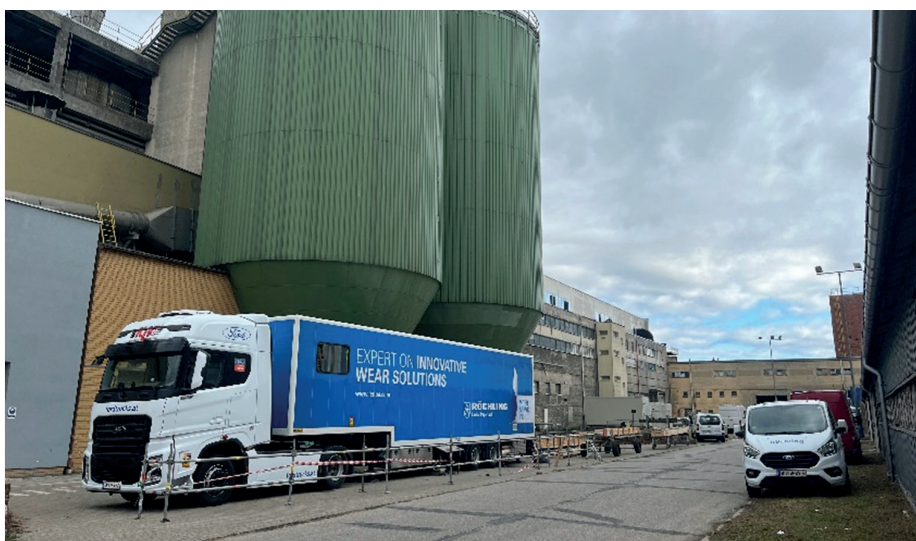
## GRINDING TRUCK AND SERVICE OPERATION

Disassembly, assembly and grinding work was carried out on the PM1, PM2, PM3, PM4 and PM7 machines. A total of 12 covers and 27 foils were replaced.

Seven Röchling technicians were at the machines for thirteen days. The ROBASERV grinding truck worked for a total of around 200 hours - exactly 100 foils and one cover were ground. The technicians worked a total of 447 hours on the machines.

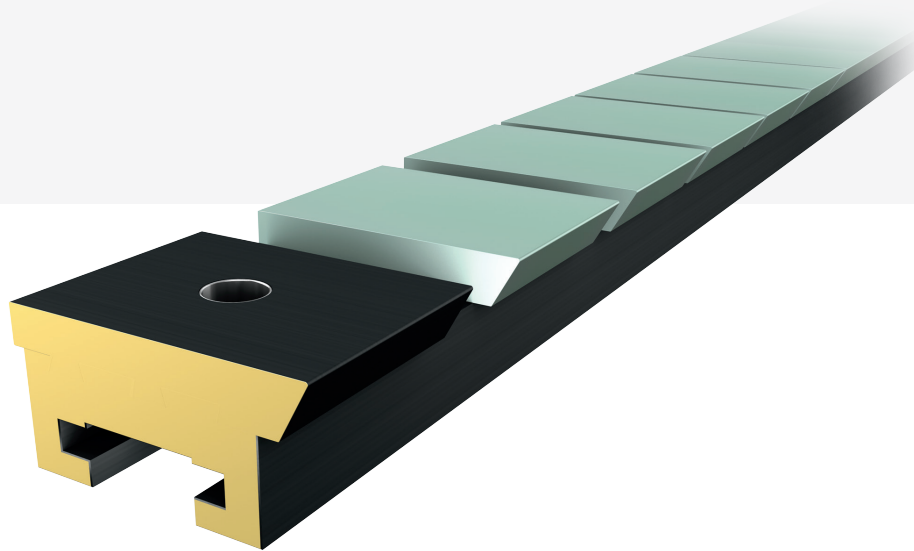
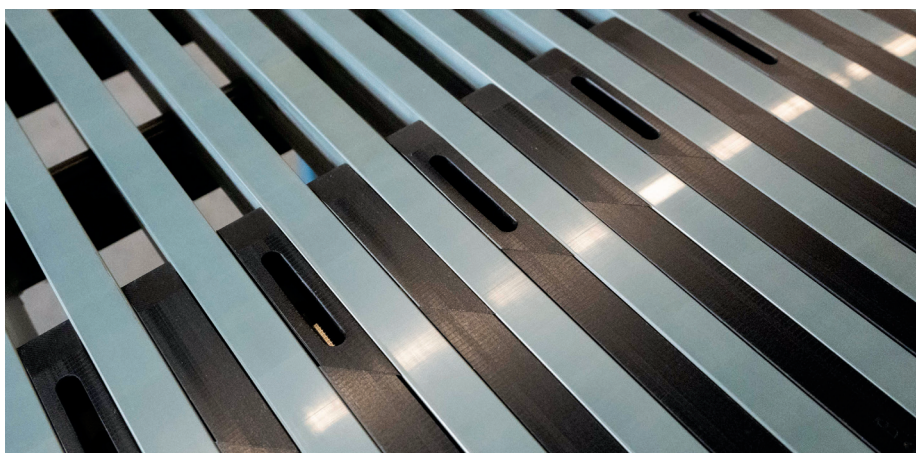
## ROBACERAM PX

The complete machine was converted from SIN to PX for all positions and the vacuum values were adjusted.

Despite the increase in vacuum on the wire section of 9 %, the drive power was reduced by 24 %.

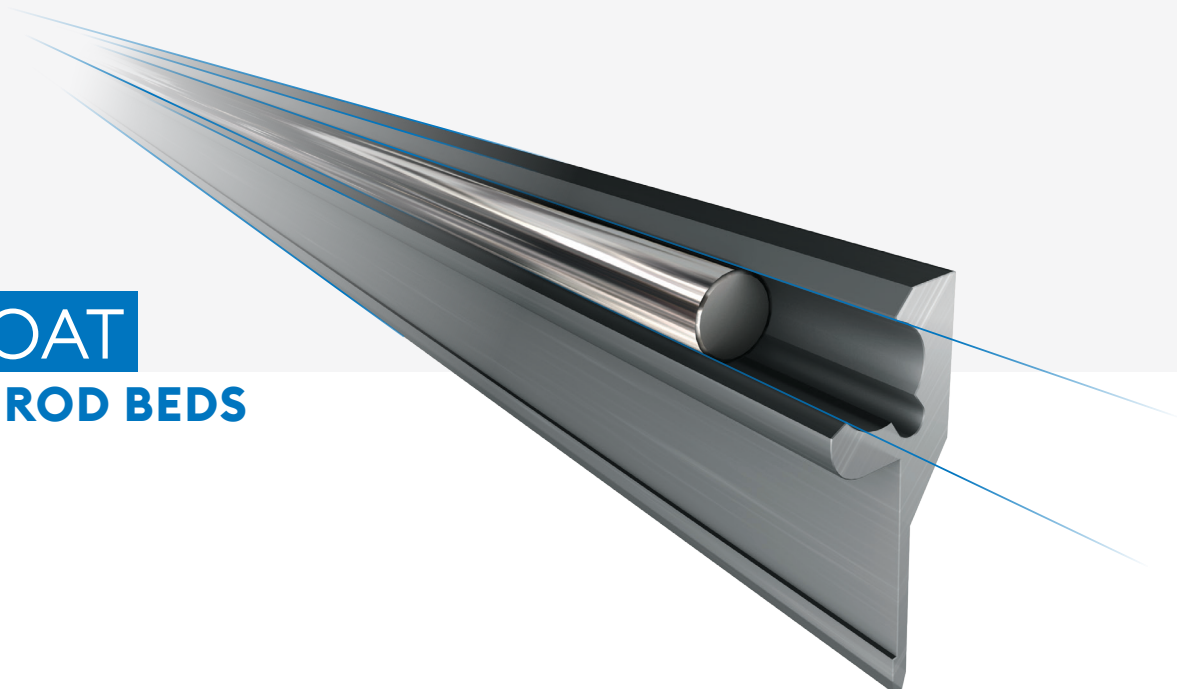
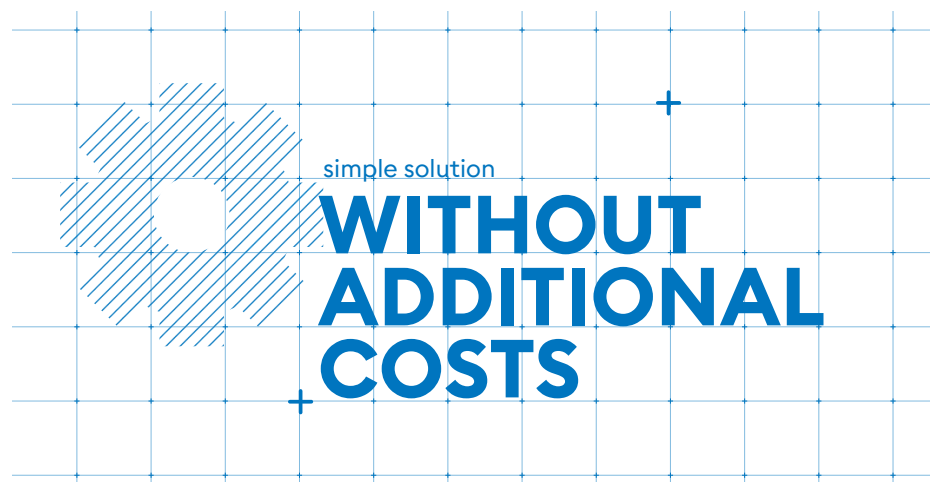
## METERING ROD BEDS

Thanks to our unique manufacturing capabilities, we were able to redesign the rod bed so that the rod was held more firmly and continuously in the rod bed. We have thus eliminated the problem of metering rods jumping out.

After many years of using our rod beds without any problems, the rod suddenly kept jumping out of the bed.

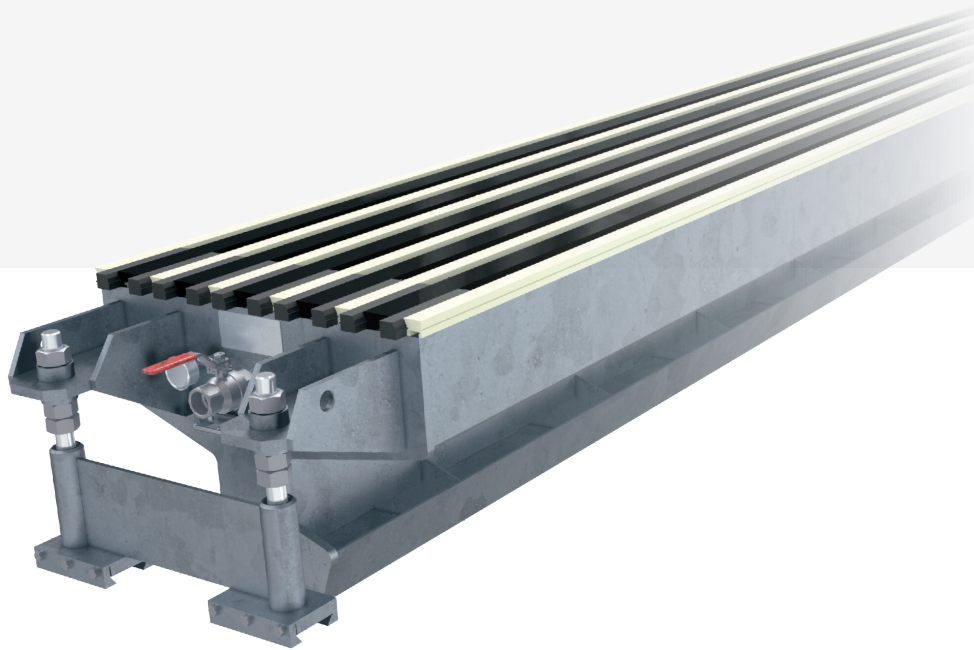
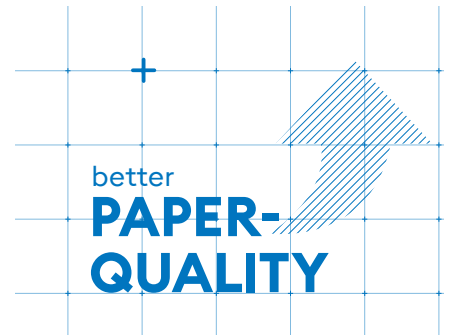
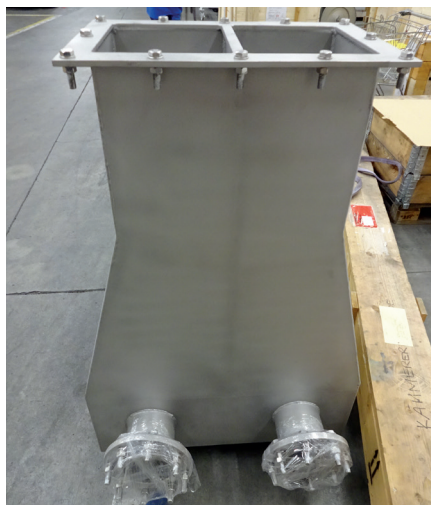
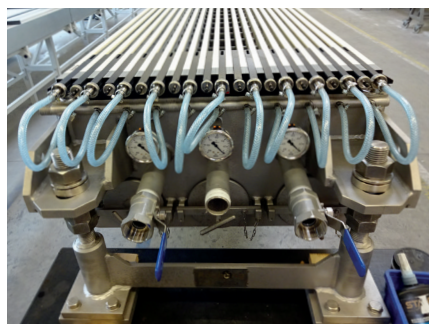
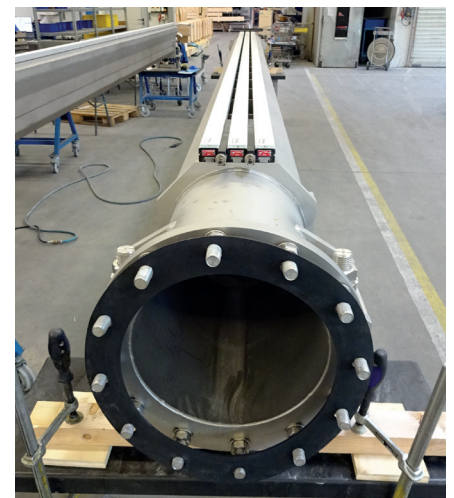
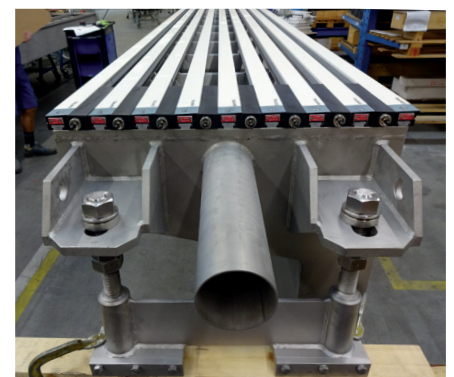
## STEEL BOXES FOR CONVERSION PROJECT

We created a simulation of the dewatering system and then supplied a new vacufoil box, three double-chamber wet suction boxes and a new Trivac box including separator.

For the conversion of the press section, we also supplied four uhle boxes and two transfer boxes.

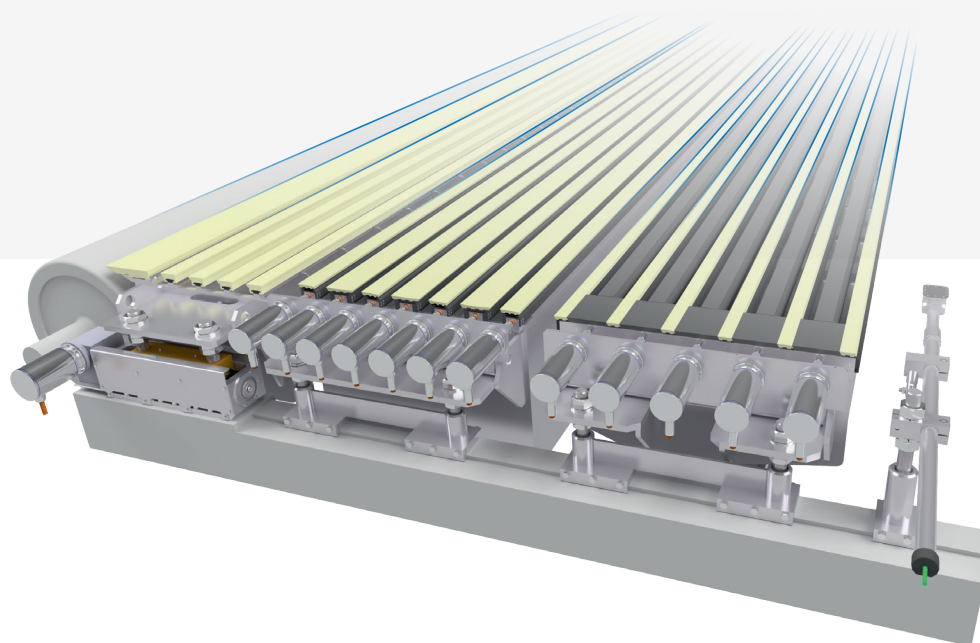
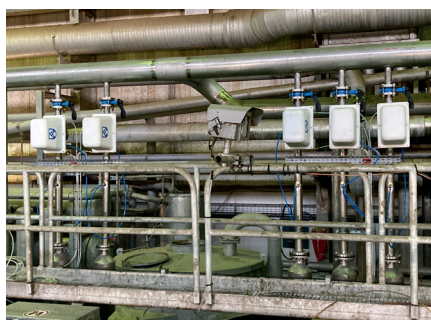
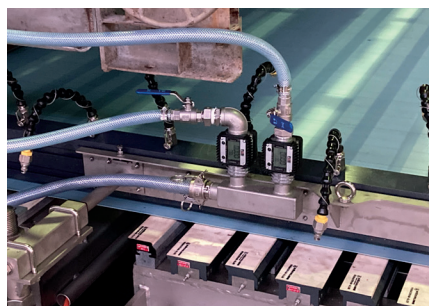
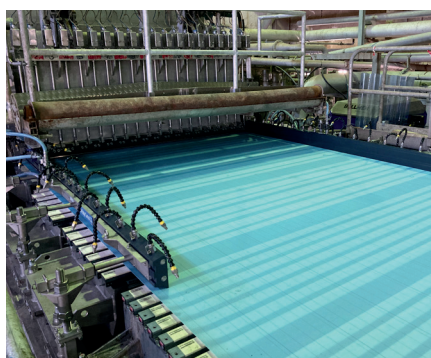
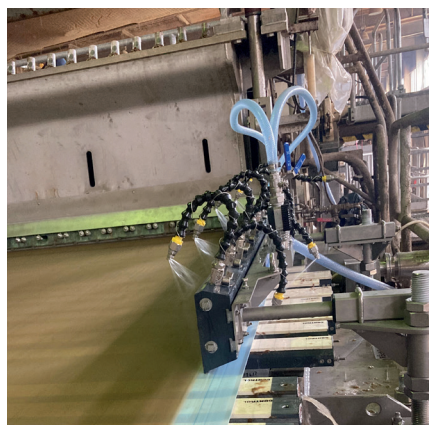
# SMARTTABLE CONVERSION PROJECT

We installed a complete SMARTTABLE. This included two adjustable forming board boxes, three hydrofoil boxes to hold Smart hydrofoils and activity-foils, two formation boxes to hold Smart formationfoils and a Trivac box.

Using 3D scanning and detailed measurements, it was possible to design the new boxes so that they fitted into the existing space. The entire pipe-work for the vacuum valves was redesigned.

Savings on strength-enhancing chemicals, formation improvement of 12 %, strength increase due to the conversion and increase in dry content.

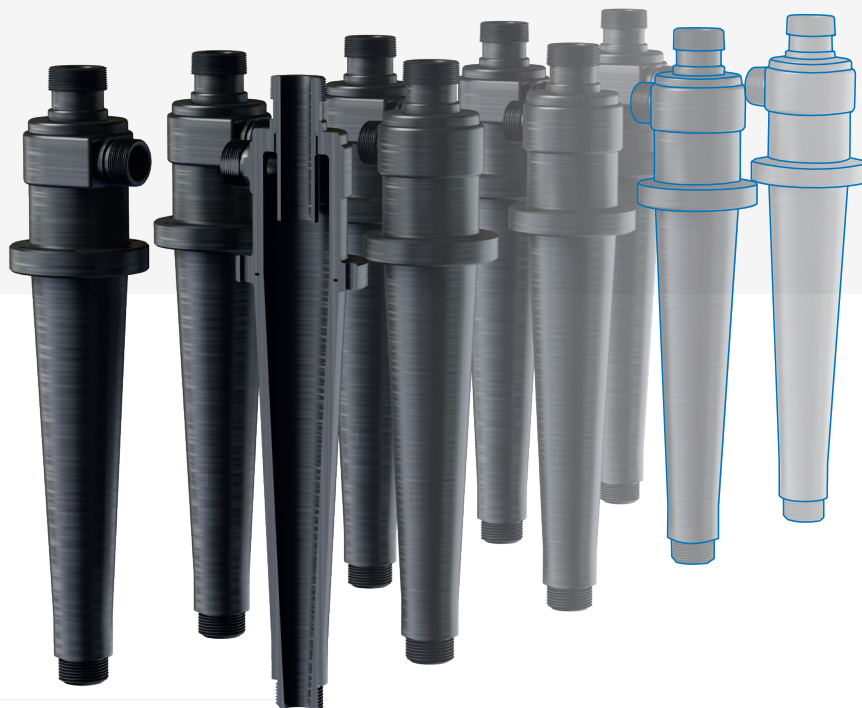
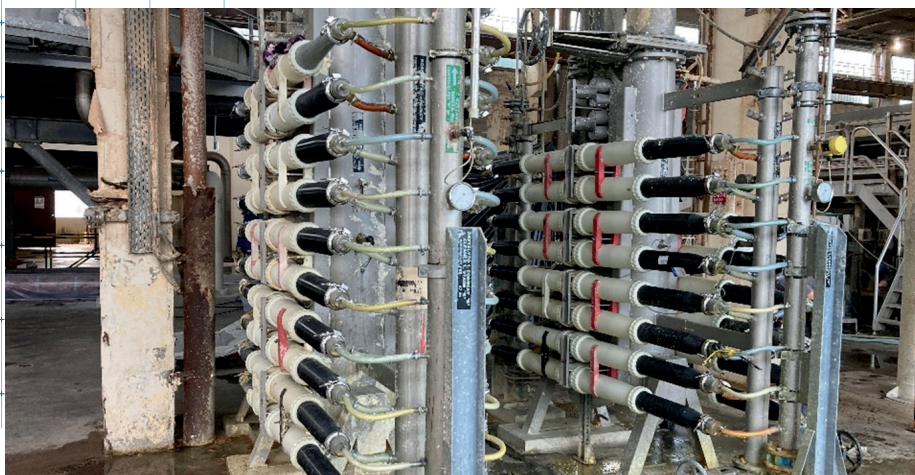
## ROBACLEAN TC133

With the ROBACLEAN TC133, the customer no longer had to shut down the system unplanned. Installation was just as easy as installing the original product.
