# Project Report

## New pickling line with Polystone® G blau B 100-RC

- High operational reliability and performance
- Pickling medium with up to 18 % nitric acid and 7 % hydrofluoric acid

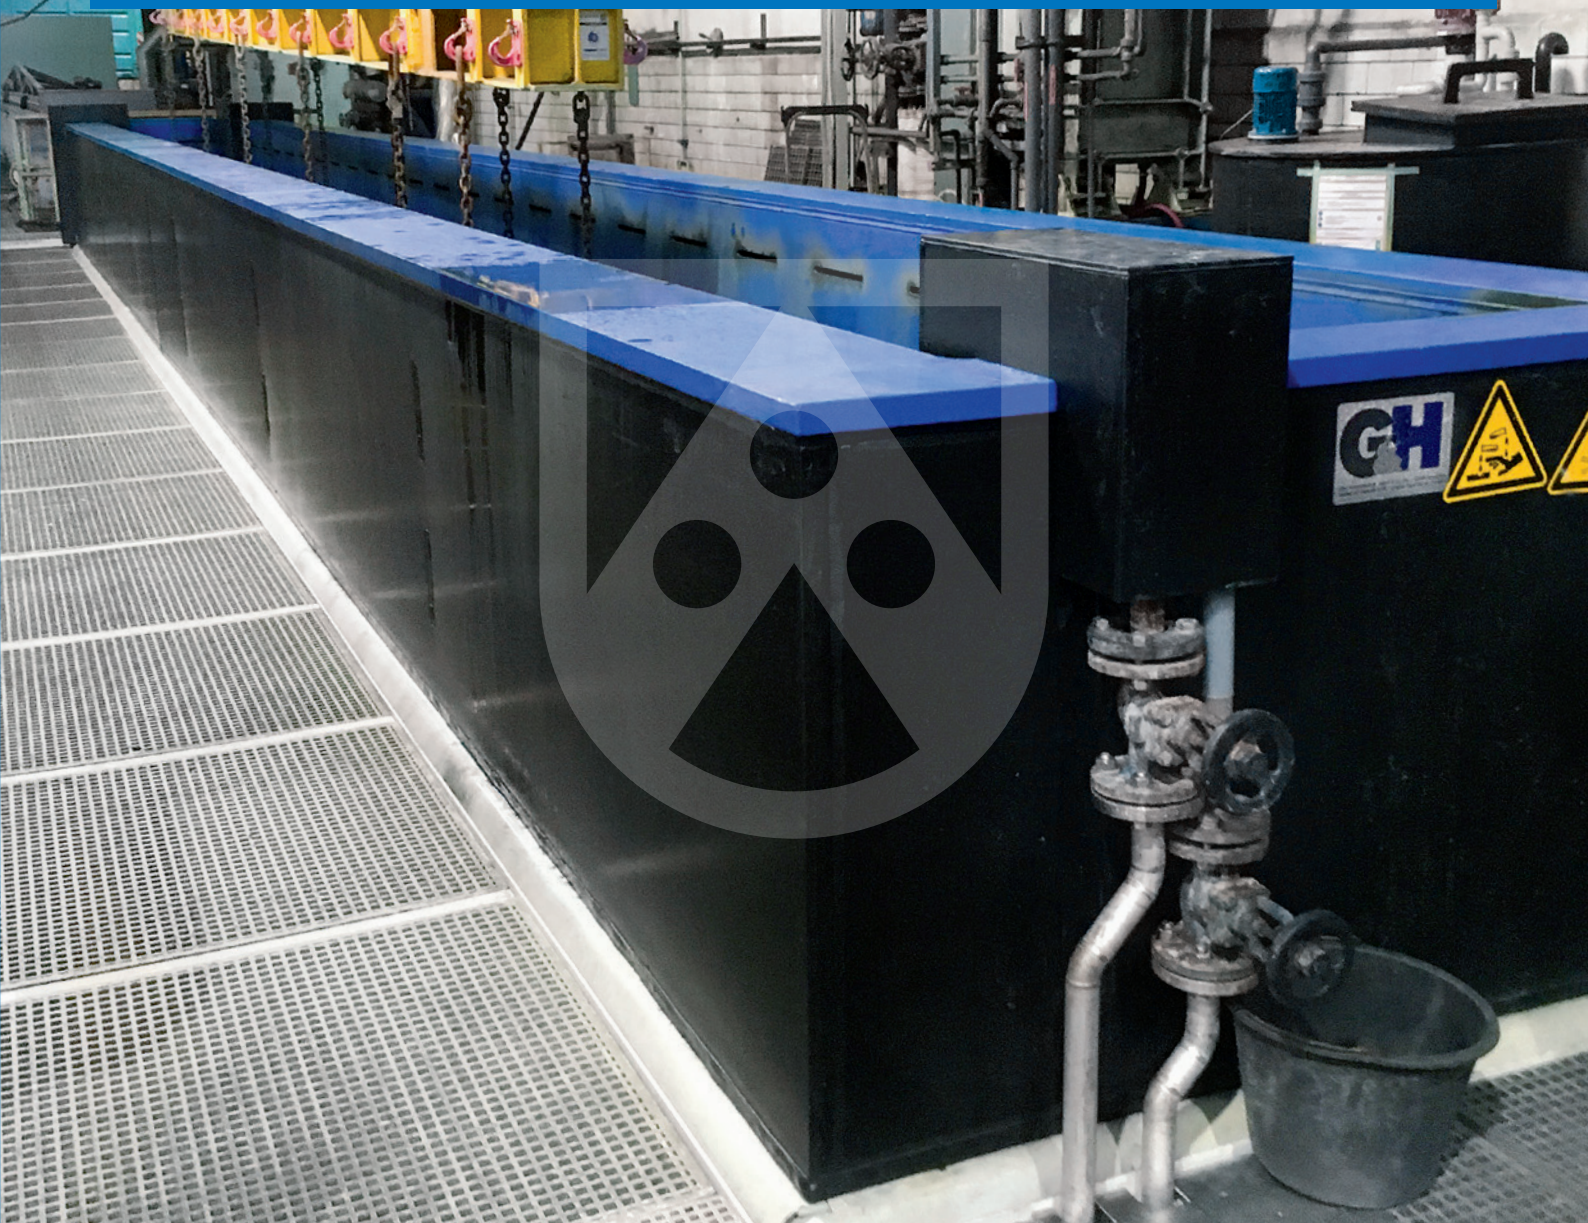
**Pickling line for seamless tubes at Mannesmann Stainless Tubes Deutschland GmbH in Remscheid/Germany:** A pickling medium with up to 18 % nitric acid and 7 % hydrofluoric acid is used

At Mannesmann, G&H familiarises itself with the task at hand. Via Autodesk Inventor, the team constructed a basin supported by a stainless steel frame with a length of almost **17 metres, a width of almost 2.5 metres and a capacity of 25,000 litres**. At the Sprockhövel site, G&H prefabricated the basin in two parts. It was finally assembled and welded at Mannesmann Stainless Tubes in Remscheid.

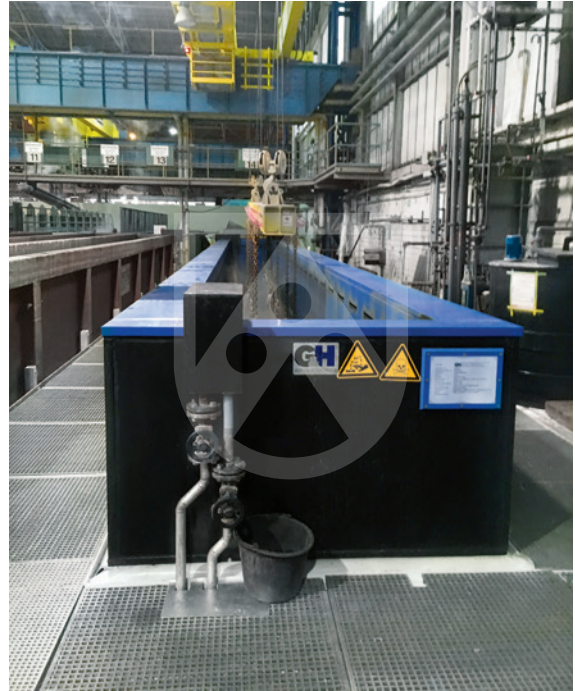
**Exterior cladding made from Polystone® G blue B 100-RC:** The material is suitable for permanent contact with aggressive nitric and hydrofluoric acids and contributes to the plant's high operational safety and performance

G&H chose Polystone® G blue B 100-RC from Röchling Industrial SE & Co. KG in Haren/Germany as the interior cladding material for contact with the aggressive pickling medium. The plastic is a polyethylene with **excellent chemical resistance to chemical media** and high stress crack resistance – RC stands for **Resistant to Crack**. The plastic is used worldwide in process and storage tanks with media that cause stress cracking. Gödecke explains: “Our experience has shown that Polystone® G blue B 100-RC is very well suited for chemical apparatus engineering. The material is suitable for permanent contact with the aggressive nitric and hydrofluoric acids used at Mannesmann Stainless Tubes. The plastic thus contributes to the reliability and longer service life of the new pickling line.” The material also offers high impact resistance at low outside temperatures. This is important because the tank is located in an unheated hall. “The tank is exposed to considerable temperature differences”, says Nürnberger. G&H has used Polystone® G HD black from Röchling as the exterior cladding material. The plastic Polystone® P flex was used at the foot of the exterior cladding. The material combines very high elasticity with good chemical resistance and is therefore particularly suitable for sealing gaps in galvanic or steel pickling lines.
