## Reliable even after 30 years in operation

### Lignostone® Transformerwood® Insulation parts tested for technical values

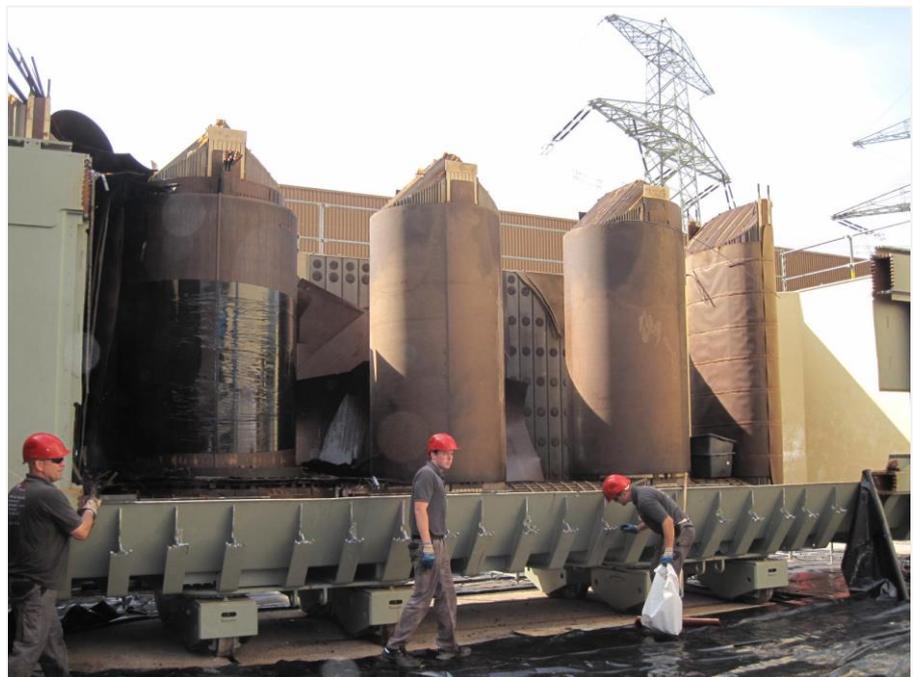
*Dismantling: The power transformer has been in operation in the Grohnde NPS since 1981; the Lignostone® components came from here for testing*

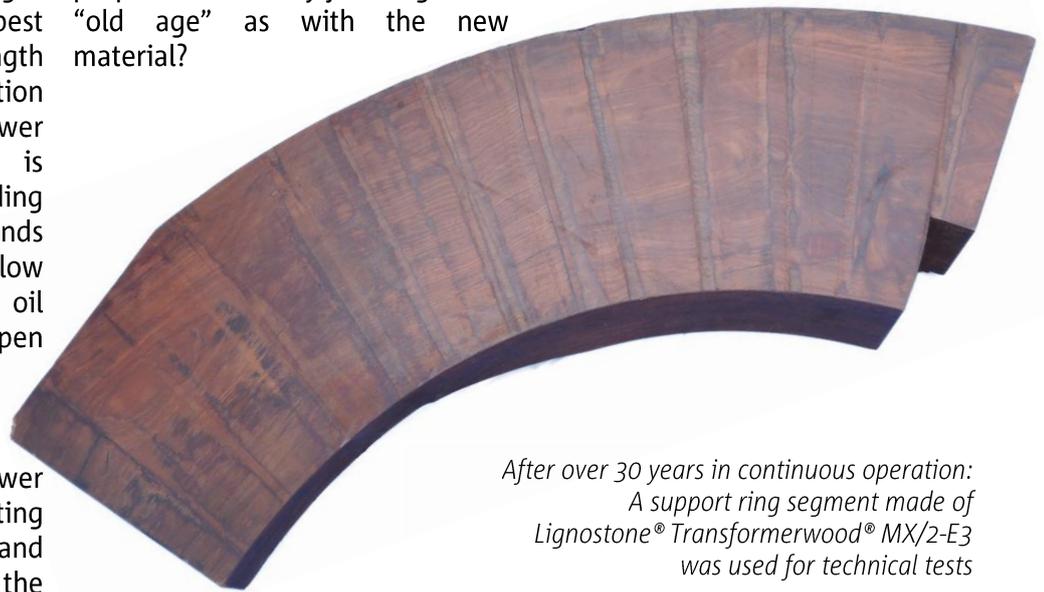
*After over 30 years in continuous operation:  
A support ring segment made of  
Lignostone® Transformerwood® MX/2-E3  
was used for technical tests*

The old components made of Lignostone® Transformerwood® were subjected to tests in the laboratory at the Haren location. How well have they got over the influences over three decades? You clearly see the long years of application on the outside. Contact with oil has made them darker. What is decisive, however, are the mechanical and electrical properties. Are they just as good in "old age" as with the new material?

The modulus of elasticity, flexural strength, compressive strength and electrical strength were also measured. The upshot: Outstanding. "All the figures determined lie only slightly below or partly above the average values of new material. In any event, they are still within the scattering usual for this natural material", Hoppmann explained the test results.
